Study of accidents caused by rockfall in Kochi Prefecture

T.Ushiro, Y. Matsumoto & N. Akesaka Daiichi Consultants Company Limited, Kochi, Japan

ABSTRACT: This report aims at evaluation and study the critical behavior of rockfall situated along the roads in the mountainous region. There are approximately ten traffic accidents caused by rockfall in Kochi prefecture every year. Three of them are fatal accidents resulting in death of the drivers and passengers. A field analysis is carried out by studying the geology and tracing the path of rockfall. The motion of rockfall is analyzed based on the data gathered in the field as well as from experiments. The obtained results from the field studies and experiments are compared and the effects of trees on the rockfall motion are evaluated and discussed.

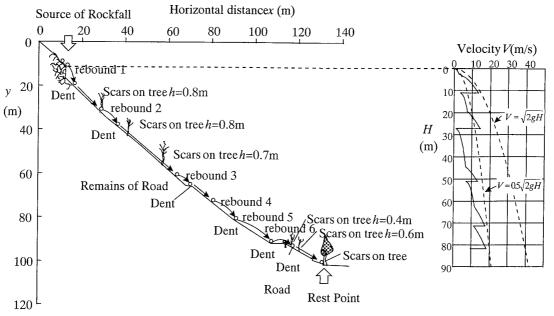
Fig.2 Shima Kitagawa Rockfall

The topography of the site is a valley, where the steepness of the slope is 41° up to remains of the road at the height of 25m from the road surface and 36° for the higher points, see Fig. 2.

There were no slip marks left on the road. Therefore, the boulder hit the running car before the driver could push the break. Impact of the rock on the right side of car at the head-light rotated the car clock wise and left the tail of car hit to the guard fence, see Fig. 4. Figures 2 and 5 show movement of the rockfall estimated from traces and tracks.

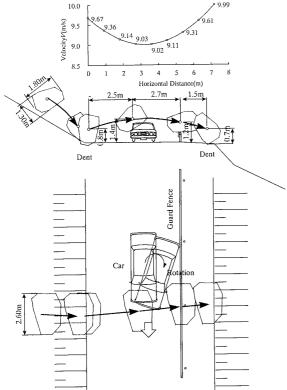
Fig.5 Rockfall Accident Diagrams (Rebound 6)

Figure 2 and Figure 5 shows the estimated velocity of rockfall. We estimated the flight path of rockfall and calculated velocity from 3 points of flight path while rockfall was in the air. We also estimated coefficient of friction on the slope to be $\mu=0.5$ and resistance of the slope to be C_k , which was constant throughout the slope. We calculated C_k under the conditions of zero initial velocity and no change in velocity when the rockfalls motion changed from a linear (slide or roll) state to a nonlinear (rebound) state. The estimated velocity of the rockfall can be given by the equation 1 as follows:

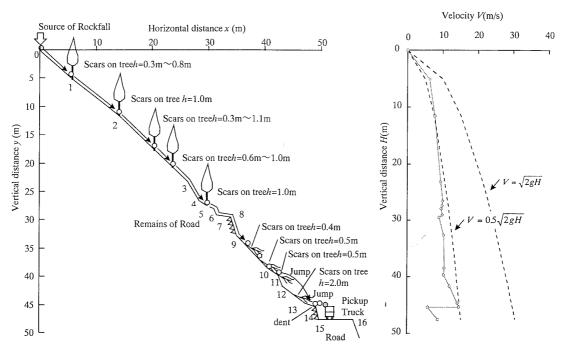
Fig.7 Cross section of Futamata Rockfall Slope

The geology of the site is Southern Shimanto belt, which consists of sandstone and shale. The slope was covered with $1\sim2m$ thick residuals. There were many $0.3m\sim0.5m$ boulders on the slope. However, boulders of equal sizes located only over 47m above the road caused the accident. The source of rockfall was 47.6m above the road. There was a scarp face supplying boulders above 20m of the source.

The average steepness of the slope up to 18.1m above the road, where remains of the road existed, was 49°. The average steepness between the remain of road and the source was 41° and it was steeper for higher points. The average steepness between road and the source was 44.° Vegetation of the slope was broadleaf trees for between road and remains of the road. The slope above remains of the road was a forested area consisting of cedars trunk having size of 30cm.

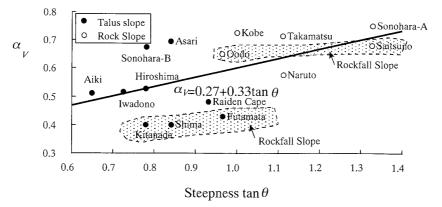
Fig. 10 Relationship between Velocity Conservation Coefficient and Steepness

Figure 10 shows relationship between velocity conservation coefficient α_{ν} and steepness of slope. Data for this figure includes actual rockfall (Kitanada, Ooto) and field rockfall experimental data. All the field experiments were performed on slopes without vegetation cover for easier observation.

When the slope was talus, velocity conservation coefficients of actual slopes were 25% smaller than experimental slopes. This could be the effect of trees. There was no difference in velocity conservation coefficient between actual and experimental slopes for rock slopes. This is because there was less trees on rock slopes thus energy loss by trees was smaller.

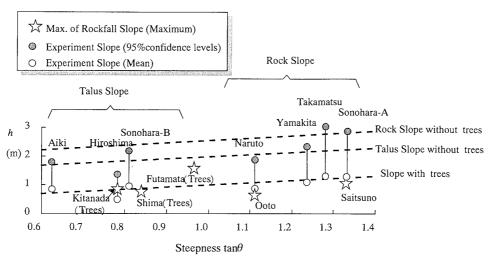
Fig.11 Relationship between Jumping Height and Steepness

Figure 11 shows relationship between estimated rebound height from scares on trees and steepness of slope. Data for this figure includes actual rockfall (Kitanada, Ooto) and field rockfall experimental data. We used maximum rebound height in actual slopes, reduced 95% of average for confidant rebound height in experimental slopes.

The rebound heights of actual slopes were 1.0m smaller on talus and 1.5m smaller on rock surface than experimental slopes. This can be explained by energy loss by trees.
