Study of accidents caused by rockfall in Kochi Prefecture

T.Ushiro, Y. Matsumoto & N. Akesaka Daiichi Consultants Company Limited, Kochi, Japan

ABSTRACT: This report aims at evaluation and study the critical behavior of rockfall situated along the roads in the mountainous region. There are approximately ten traffic accidents caused by rockfall in Kochi prefecture every year. Three of them are fatal accidents resulting in death of the drivers and passengers. A field analysis is carried out by studying the geology and tracing the path of rockfall. The motion of rockfall is analyzed based on the data gathered in the field as well as from experiments. The obtained results from the field studies and experiments are compared and the effects of trees on the rockfall motion are evaluated and discussed.

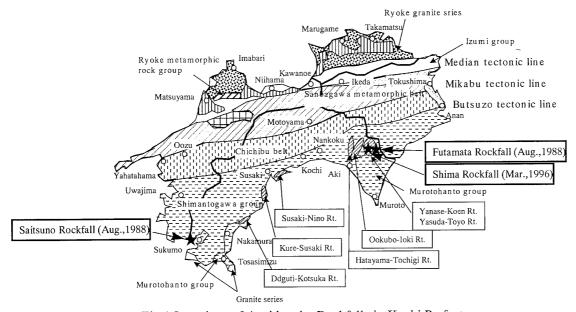
Fig.1 Locations of Accident by Rockfalls in Kochi Prefecture

The total area of the Kochi Prefecture, shown in Fig. 1, is 7,107km² and its 84% is covered by mountains. The total length of roads in Kochi prefecture is 12,615km consisting of 1,074km national road, 1,063km regional road, 964km prefectural road and 9,515km local road. These roads mainly pass through the steep mountainous region where only

Because of the climate and geography of the region, many rockfall accidents and incidents have been reported every year. In what follows some important of them will be analyzed and discussed.
